## How High-Frequency GPR Solved a 2,000-Year-Old Transport Dilemma for the Antikythera Statues

## STATUE "WRESTLER OF ANTIKYTHERA"

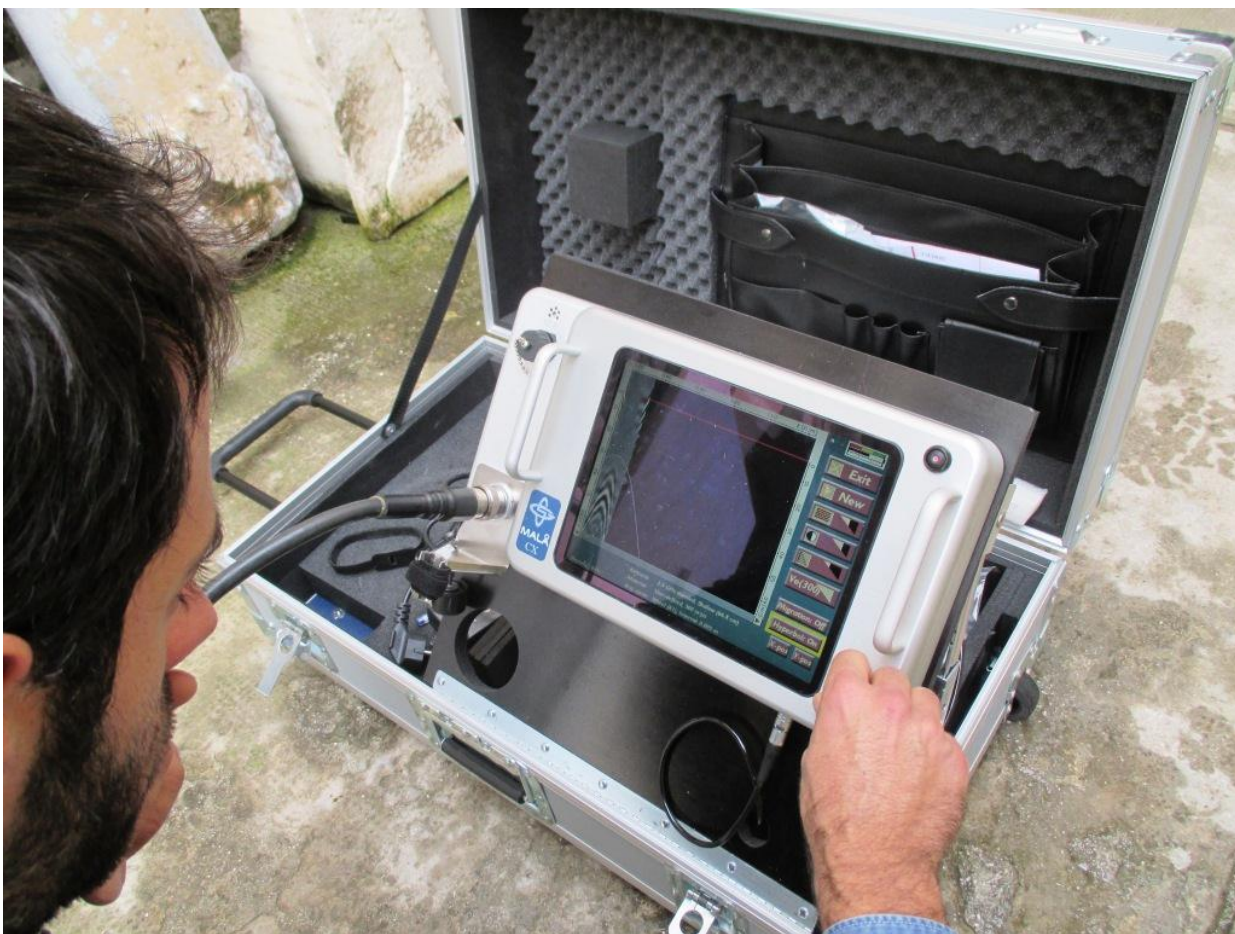
For this reason, one specific velocity calibration was carried out in one flat surface of white marble. The measured/calculated velocity was found to be 10,2 cm/nanosecond.

*Figure 1 Calculation of the propagation velocity in the marble using the method of "hyperbola fitting" of the 3D-Vision software*

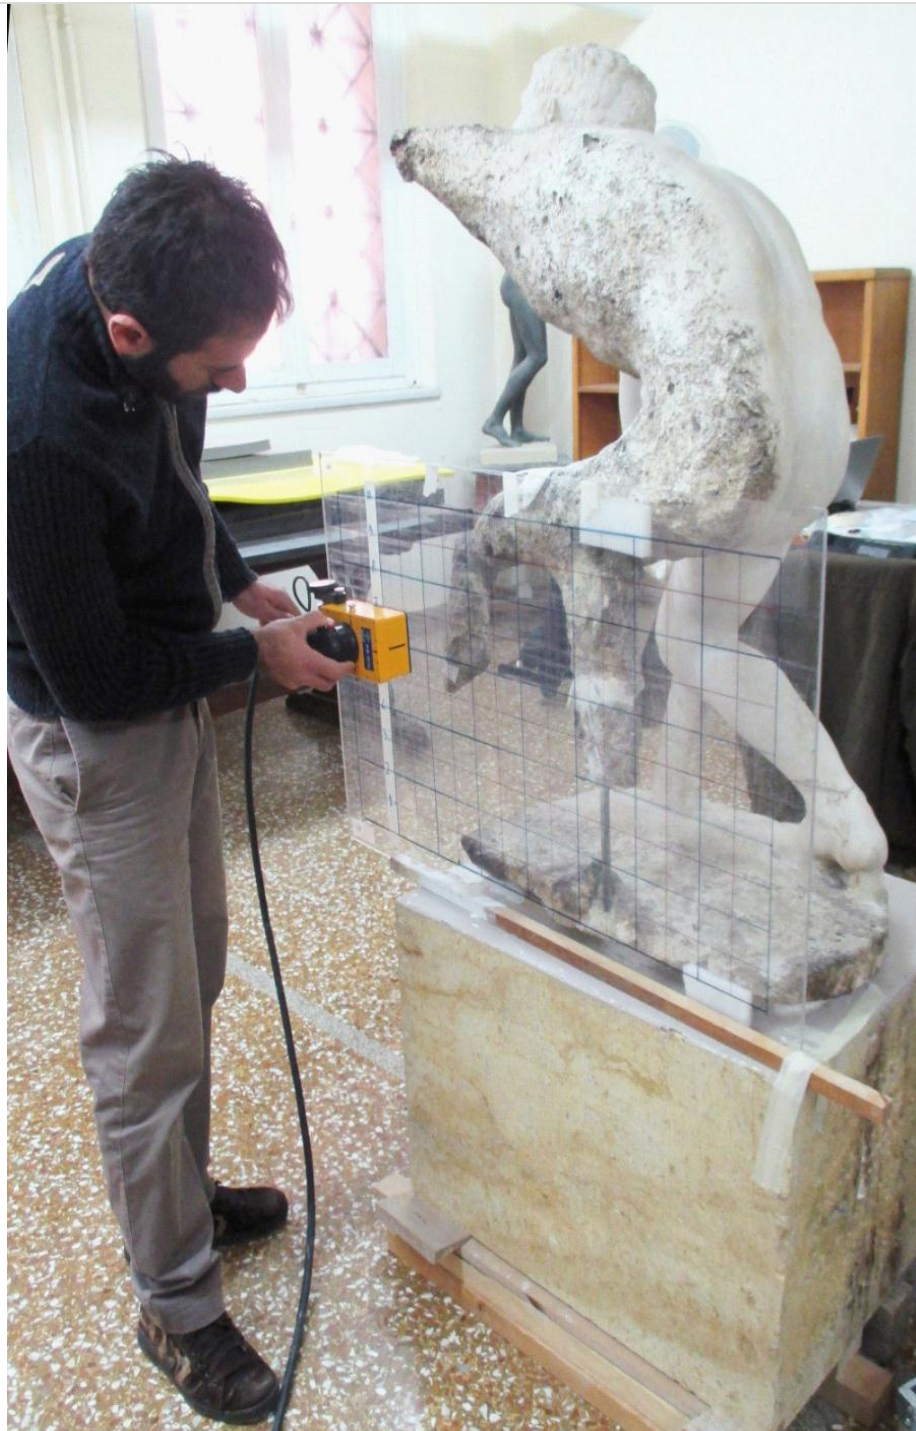
We have used the GPR CX-12 of MALA GEOSCIENCE. The process of scanning was based in performing one two dimensional grid of parallel scans with a grid size (cell) of 5 cm. The X and Y sizes of the grid varied according to the specific area to be investigated. For each target, one separate grid was performed.

*Figure 2 The process of scanning one specific area of the statue "Wrestler of Antikythera"*

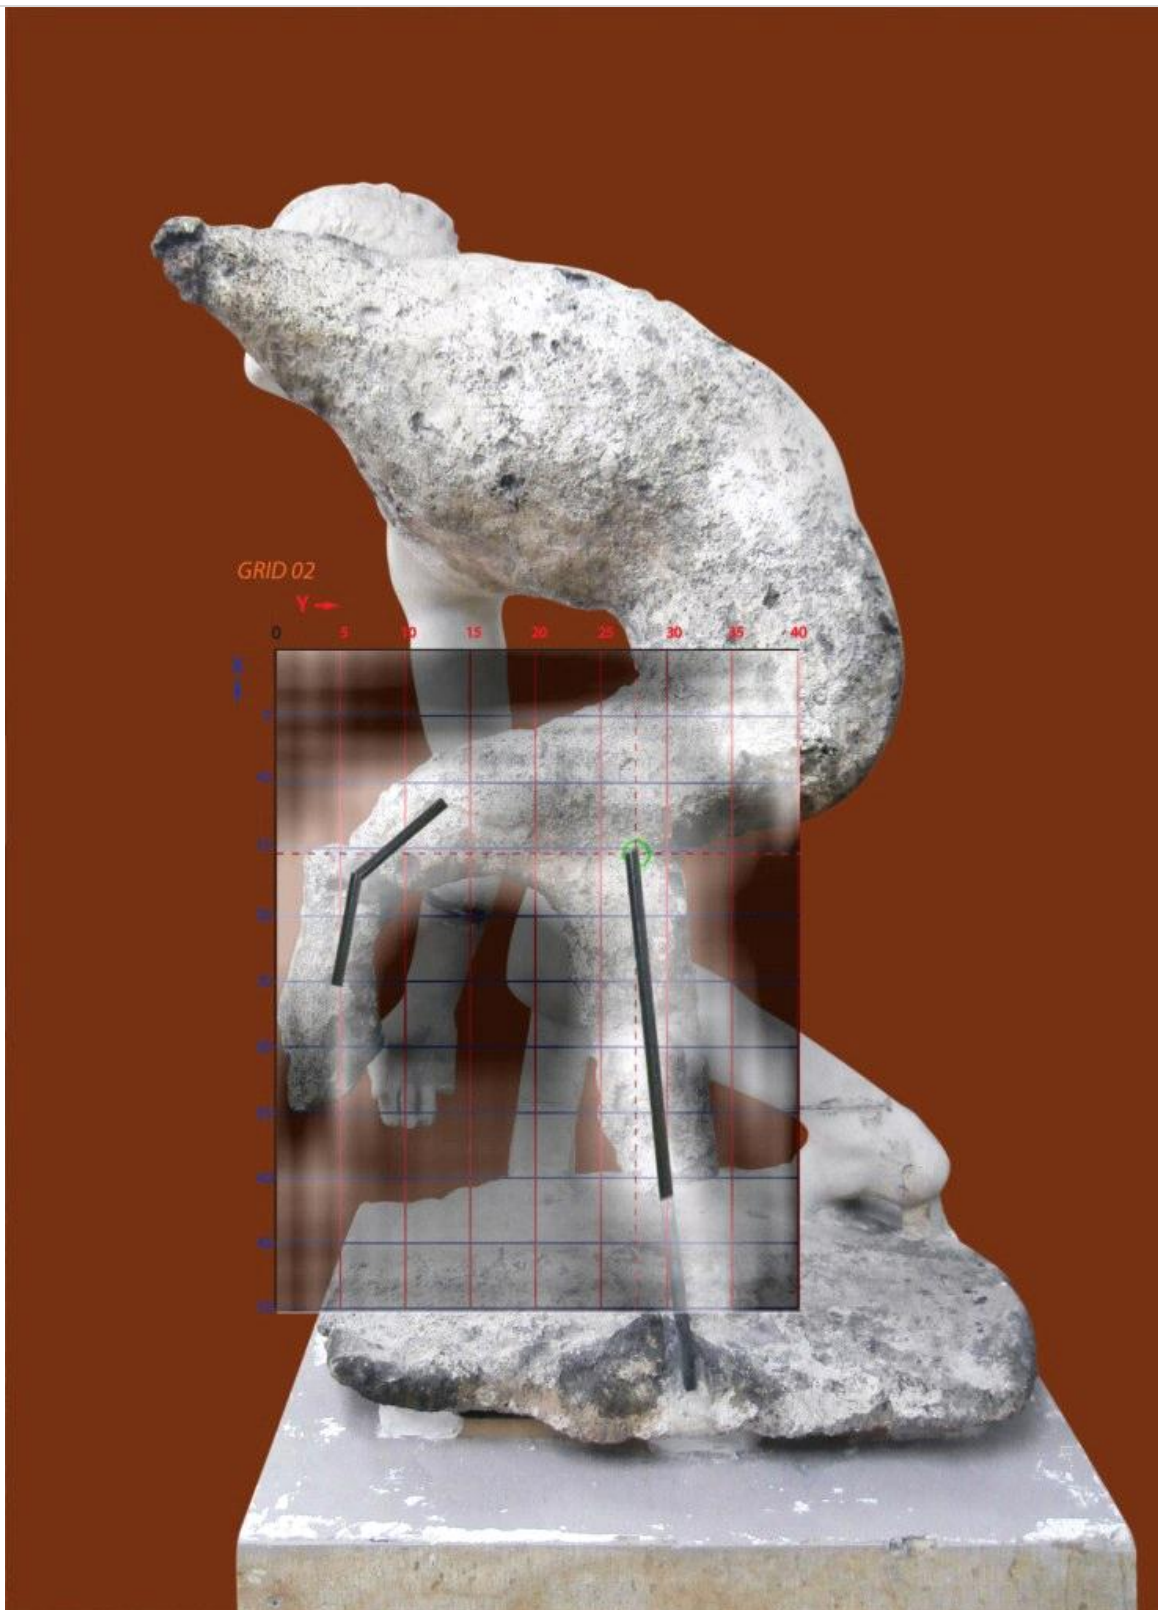
According to the visible cracks, three specific grids have been installed to examine the statue. The result of the raster output from the GPR scan, shows the emplacement of the internal metal bars. In fact the metal

acts as a strong reflector and produces one whitish area in the 3D slices. By replacing the fiberglass grid with one virtual graphics grid and adjusting the images, the location and the extent of each metal bar is mapped on the statue. In this form of visualization, all the following results have been derived from the measurements.

*Figure 3 Superposition of the raster image from the GPR scan on the statue (Wrestler of Antikythera)*

- **The "Wrestler of Antikythera":** GPR scans across high-stress zones confirmed metal dowel placement at every visible external crack. Interestingly, scan data across the right arm revealed reflection signatures characteristic of iron corrosion product expansion—indicating a reinforcement likely inserted during the ancient sculptor's production phase rather than modern restoration.
- **The "Hermes of Antikythera":** Scanning confirmed structural integrity throughout the head assembly while mapping the exact embedment depth of support pins in the lower and upper right foot sections.
- **The "Helmeted Statue":** Extensive internal metal networks were mapped across heavily corroded sections, providing the exact load-bearing data necessary to model the statue's static capacity during transport.
